Rapid boiler feed pump repair and root cause analysis ensure power generation reliability

At a time when national electrical grids are under extreme pressure, unexpected outages can prove to be a considerable challenge. When a power plant in Germany experienced the sudden failure of a boiler feed pump, output dropped by more than 40%, which affected both the local grid and company profits. Needing to resolve this situation urgently, Sulzer was called in to repair the asset and conduct an investigation to secure the reliability of the power station

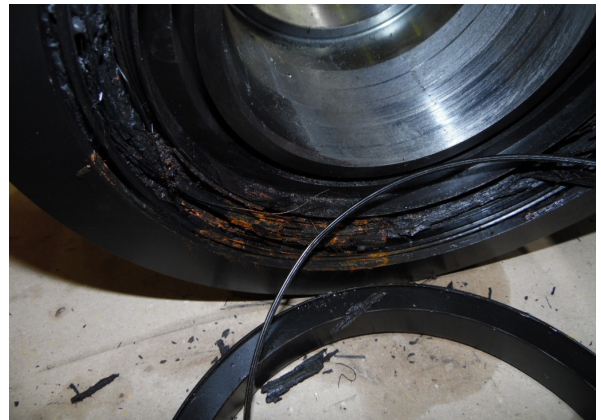
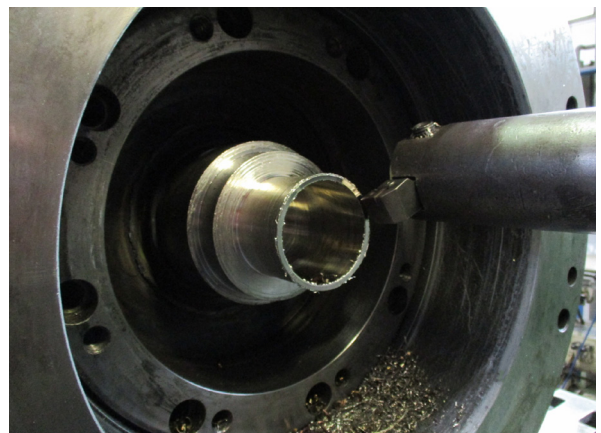
The Jänschwalde service center staff worked two shifts per day to minimize the time required to get the pump back up and running.

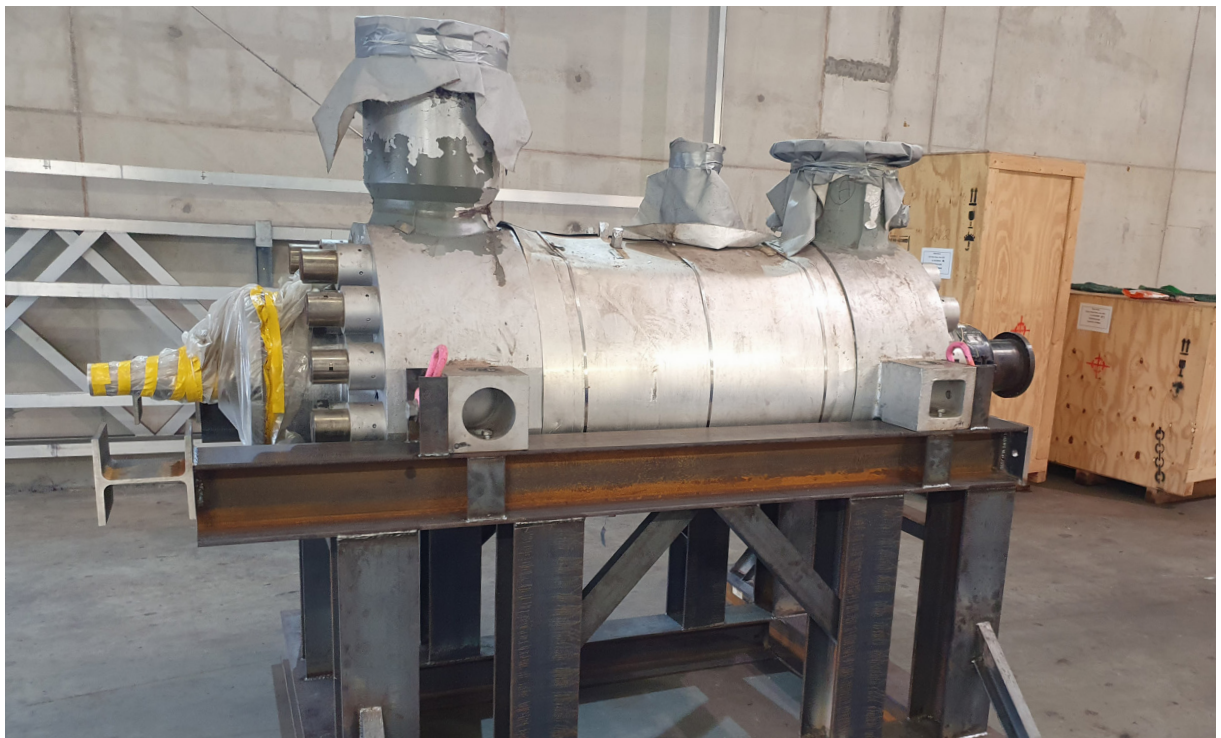
The pump was removed and transported to Sulzer's service center in Jänschwalde to enable the necessary repairs to be completed
