## Custom modified part reduces downtime costs for SAG mill operations

Gold miner

Sumatra, Indonesia

Motor services

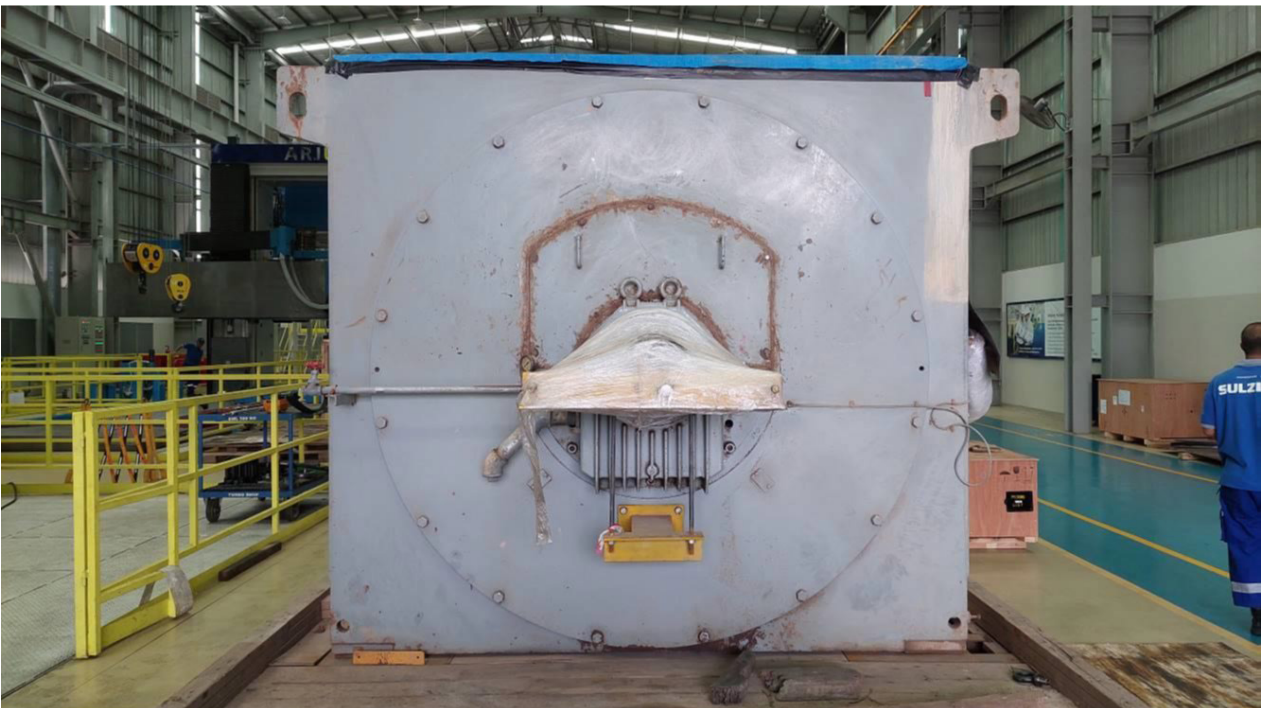
Slip ring end bearing housing removal
