## Mitigating deadly mining risks with tight motor repair turnaround

| CUSTOMER | A leading international metals company |
| LOCATION | Papua, Indonesia |
| KEY SERVICES | 1. Motor repair<br>2. Parts supply |

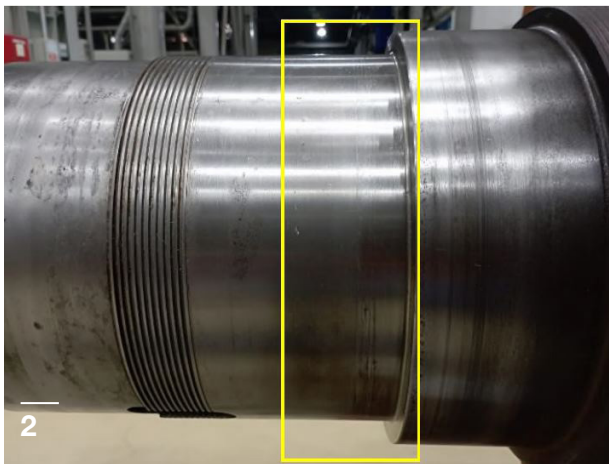
1. Stator core

- A Megger test conducted on the IR stator winding failed.
- Several stator winding coils had burned.
- The 5,000 kW Toshiba fan motor was dusty and severely corroded.

- The rotor, which exhibited minor damage and required polishing.
- The stator, which needed a thorough cleaning and rewind
- The bearings and seals, which needed to be replaced due to wear and tear.
- The fan blades, which required cleaning and repainting.
