Machinery diagnosis

- Troubleshoot vibration and mechanical issues
- A clear route to reliable equipment

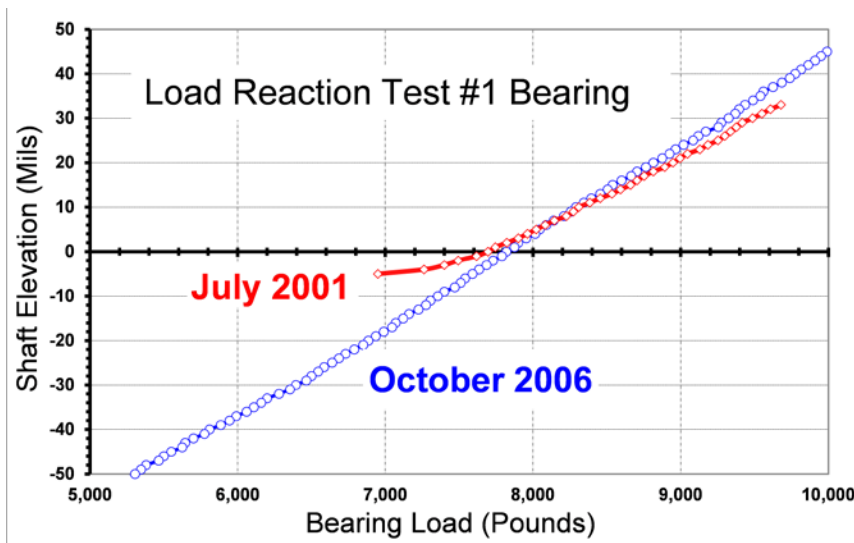
The results from this test are presented in the next graph. It is clear that elevation versus load was identical between the initial measurements from July of 2001 and October of 2006. Since the loading was identical, and the #1 bearing bottom half was wiped, it was necessary to reshoot the train optically. These vertical bearing position measurements revealed that the #1 bearing was sitting 30 mils higher than necessary, and the effective loading was substantially increased.

In the final evaluation, previous shaft vibration at 30 megawatts was 4.9 Mils,pp in March of 2006. Removing 30 mils of shims from the front standard allowed the train to run at desired output rate of 44 megawatts with only 1.5 Mils,pp of shaft vibration at the #1 bearing.
