# Revitalizing a 99-year-old hydropower turbine in record time

West Java, Indonesia

Hydropower

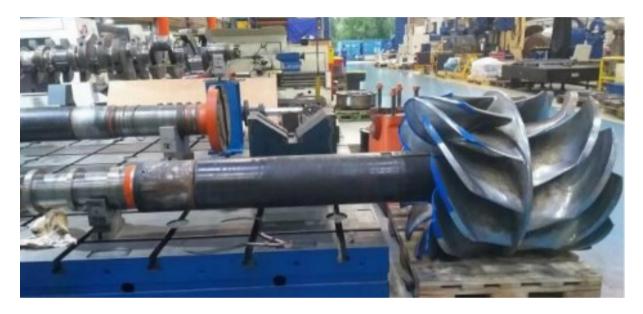
After almost a century of reliable operation, the support bolts installed on one of the turbine shafts at a hydropower plant in West Java finally failed, causing uncontrolled running. This resulted in complete turbine failure and an energy shortage, so the IPP approached several independent service providers (ISPs) for a solution, but no suitable proposal was forthcoming.

- The turbine shaft had split completely in two and the casing had been smashed to pieces
- Additional damage had been caused to the turbine tips, runner casings and the bearing pedestal
- The IPP urgently required a repair from a specialist in legacy equipment
- The lead time for sourcing new parts from the OEM was 12 months
- Local communities were suffering an energy shortage, with increased stress being placed on the wider grid to cover the shortfall

- To avoid a long lead time for a replacement shaft of the correct size, Sulzer used SAW to apply an upgraded, high-strength low-alloy steel weld material to build up the diameter of a smaller, locally sourced shaft in the coupling area - a technology transferred from Sulzer's Houston Service Center
- The turbine blade tips were welded with corrosion resistant material, supported by laser scans and reverse engineering techniques to ensure the right dimensions
- Sulzer reverse engineered the elbow casing, using metal stitching to connect the pieces back together
- The shaft and rotor were reassembled and underwent low speed balancing and demagnetization in-house
- Damaged runner casings and bearing pedestals were also fully repaired and a new sleeve manufactured, ensuring a turnkey approach, further supported by precision machining, inspections, non-destructive testing (NDT)

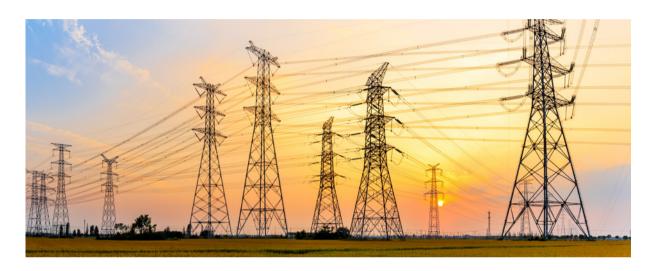
Sulzer's world-class welding capabilities and wider engineering expertise ensured the multiple, complex rotating equipment assemblies could be fixed. Experience working with legacy equipment from any brand ensured familiarity with the application and the ability to service equipment which is almost a century old. The turbine was quickly returned to operation, alleviating the local energy shortage and resuming supply of renewable electricity.
