## Cross-country coordinated effort for steam turbine restoration & reverse engineering

# Struggling for OEM's support to revive 5MW steam turbine

# Shrewd technical evaluation pin-points targeted repair for effective restoration

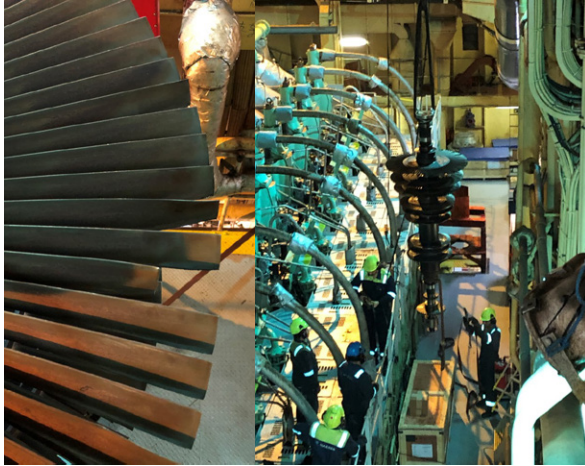
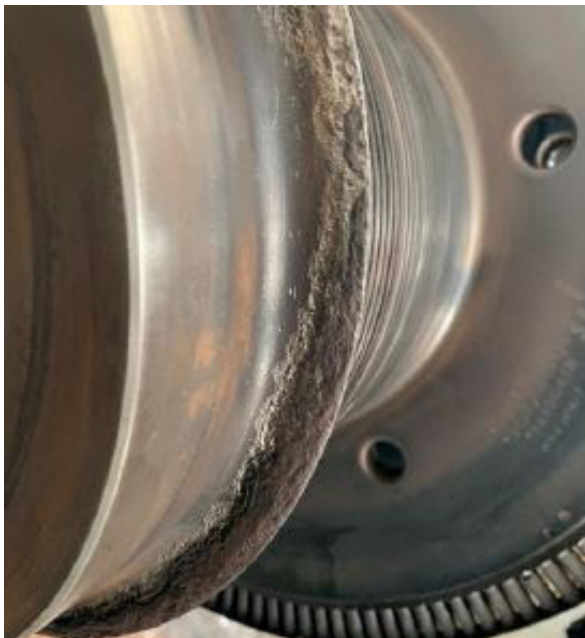
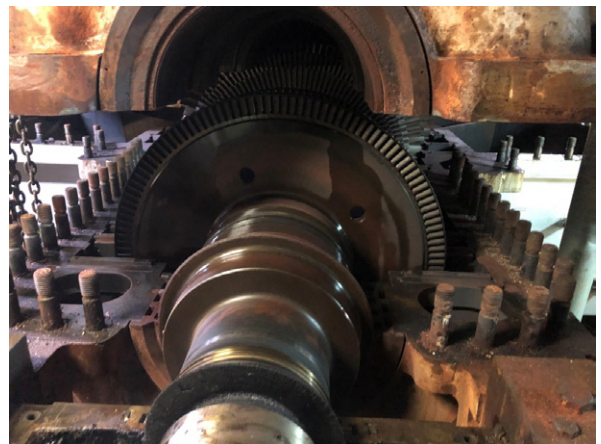
- Upon on-site evaluation by Sulzer's experienced technical experts, the damage was more extensive than expected by the customer's maintenance team
- Some of the key damages were:

- Rotor had visual damage on the 3rd, 8th & 9th stages
  - The 3<sup>rd</sup> stage trailing edges have impact damage but no visual cracks
  - 8<sup>th</sup> stage has blades that were bent and cracked

- 9<sup>th</sup> stage had various visual cracks and a complete broken blade
  - Broken bolts in the upper cover diaphragm while retaining rings can't be removed

- Reblading for stages 3, 8 & 9 with erosion shields to prevent future erosion
  - Replacement of labyrinths as the turbine is expected to operate over the long term

- Replacement of turbine journal and thrust bearing due to heavy varnish & excessive clearance in thrust bearing
  - Rotor journals to be polished to remove light scoring
