# Case Study

## Design Changes Resulting in Lifetime Extension of Gas Turbine Rotor Blades

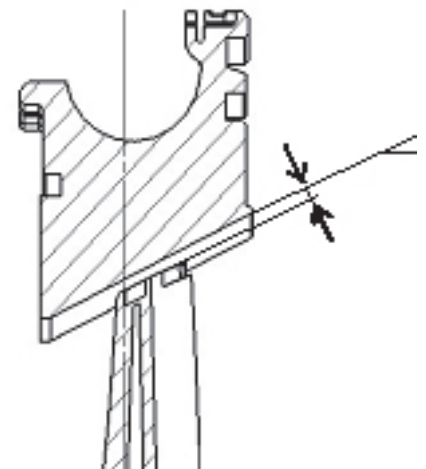
Sulzer Turbo Services developed a solution that was discussed with the customer. The proposed solution was to remove the defective material (the entire shroud), add material to increase the tip length and modify the existing shroud. (Fig. 2)

Fig 2: Blade design change from a shrouded to a squealer tip design.

All parties agreed to proceed with the manufacturing phase of the blades and mating shroud blocks. For the modification of the blade several in-house technologies were used. The main step was the removal of the tip shroud by wire EDM, powder laser weld built up of the blade squealer tip and autogeneous laser welding (joining) of the tip cap. For this particular application, all these techniques have been qualified. The quality was assured by X-ray and die penetrant inspections. The frequency of the blades was checked and parts were tuned to adhere to the set frequency specifications. An MCrAlY coating was applied to the blade surface to protect against hot corrosion.
