Rising to the challenge - Cross-country extensive restoration for steam turbine & generator

Energy major

Vietnam

Thermal power generation

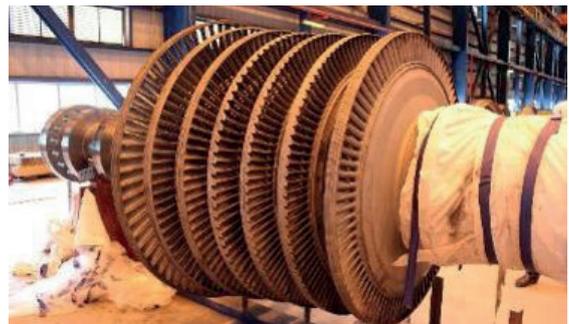
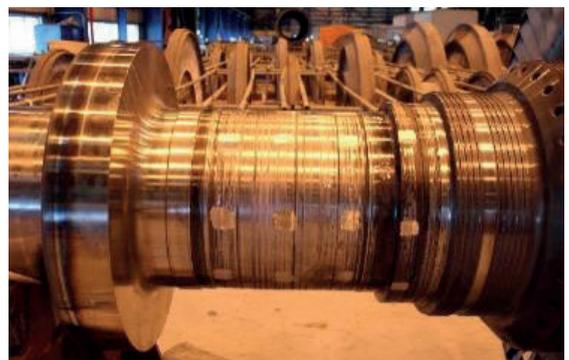
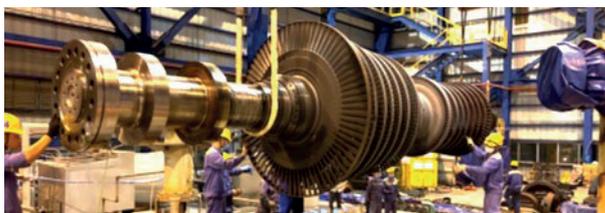
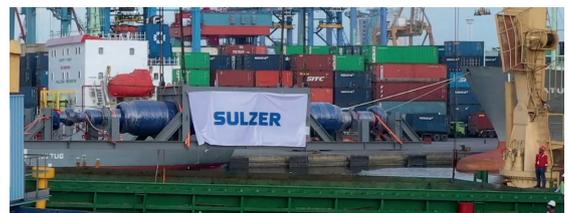
- Most of the rotating steam path parts in the unit were damaged. The unit also suffered a loss of oil lubrication, that caused the unexpected outage.
- On further examination, damages were identified in the shaft area, specifically on the journals and seals. In addition, 31 of the 39 rows of turbine blades required extensive repair and replacement.

- Repairs and replacement lead time would take a year
- Once Sulzer's experts assessed the unit, we were able to deliver good news: Instead of replacing the turbine's rotors, the energy supplier could reduce costs and wastage by repairing the turbine generator – extending its lifecycle and saving the customer millions in the process.

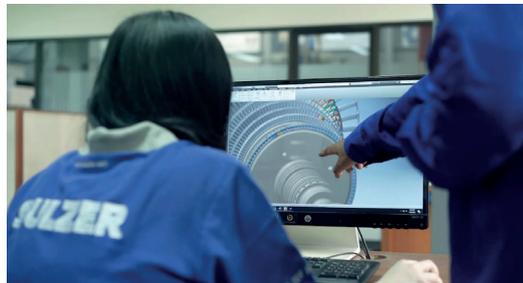
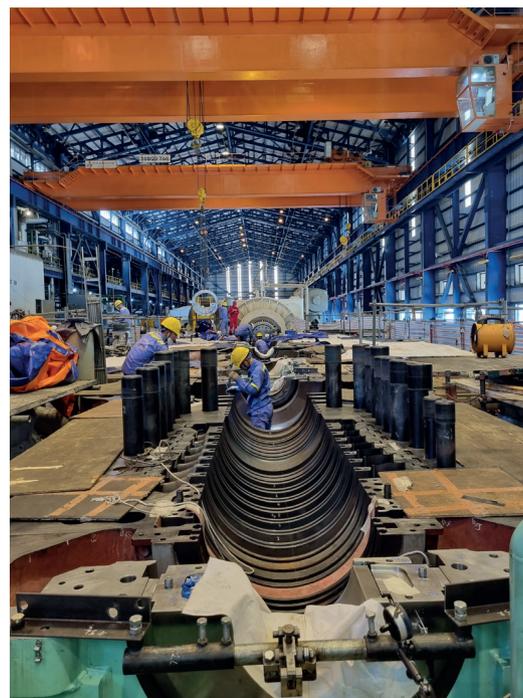
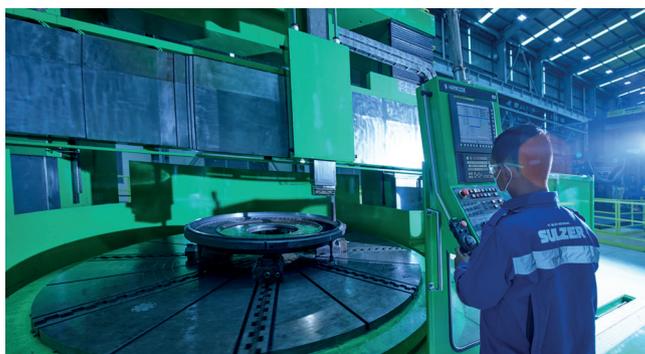
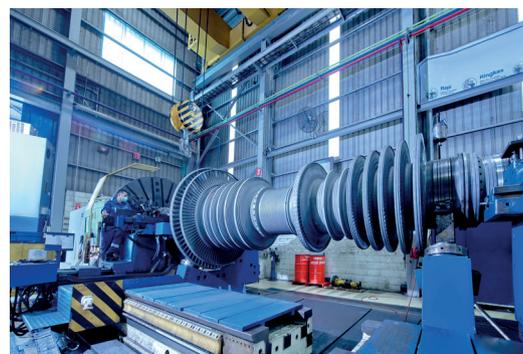
- After thoroughly assessing the situation, we established that repairs were required for most of the rotating steam path parts and shaft sections of all rotors using the weld repair method.

- Submerged Arc Welding was utilised to effectively restore the damaged areas due to its high deposition rate, compatibility with such large equipment, and its ability to fulfill high technical repair requirements.

- Weld repair on rotors is not as easy as weld repair on common workpieces. It requires high-quality material, highly skilled welders, qualified processes, and of course extensive experience.
