Sulzer called in to overhaul storm pump after extended delays

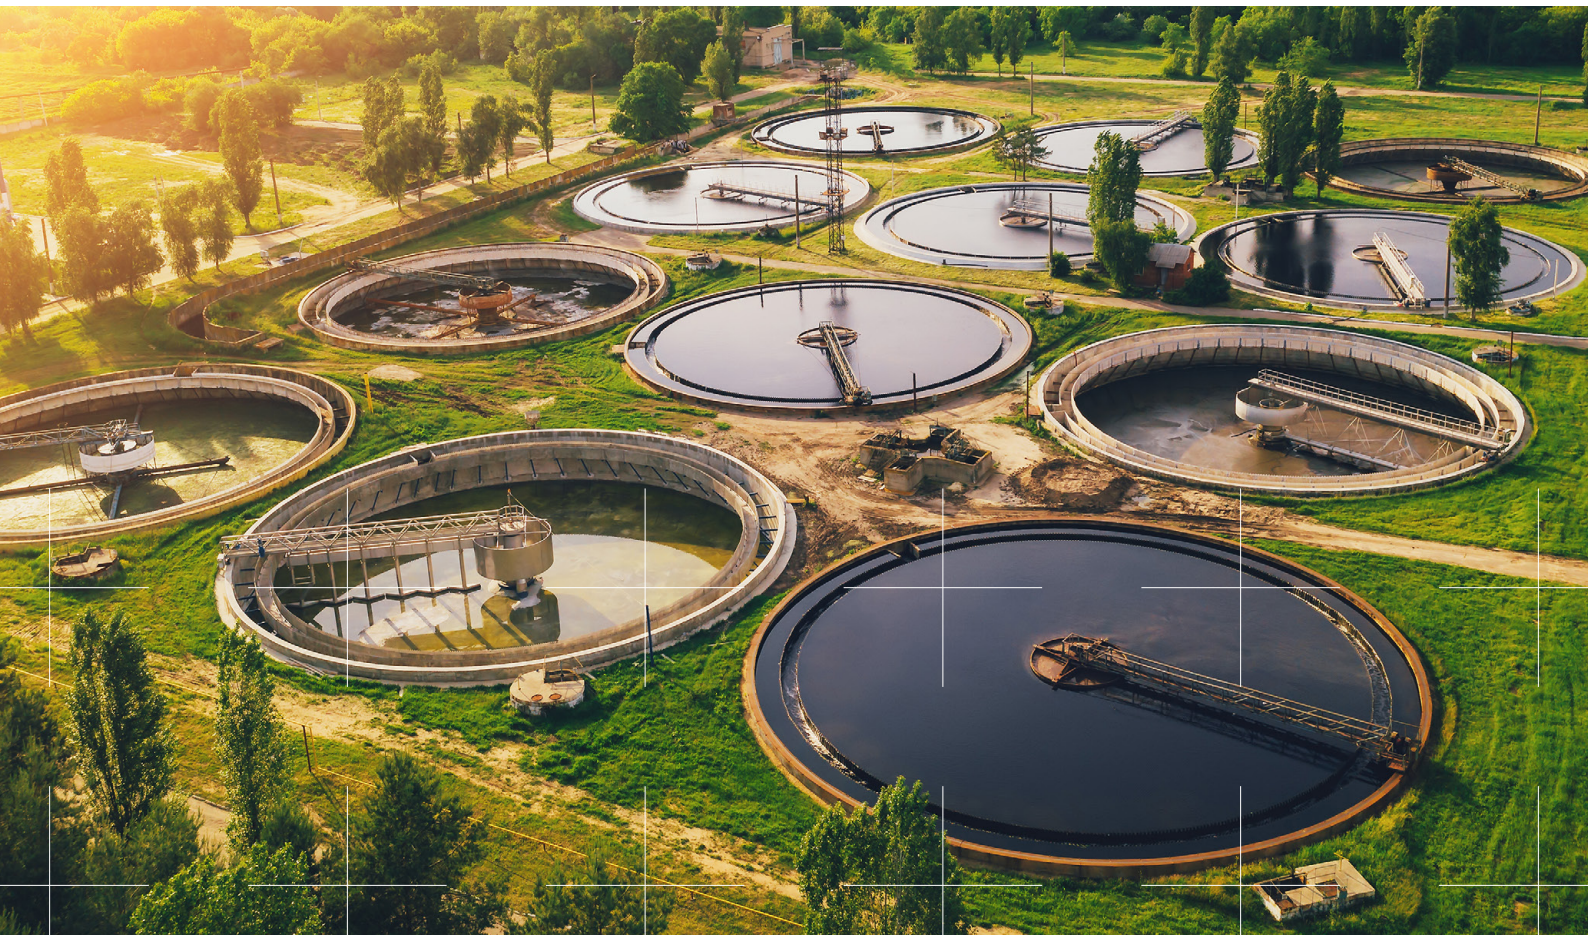
“Having detailed what Sulzer could offer in terms of support, we took the opportunity to look at the pumps during the visit. We explained how we would lift and transport both the pump and motors to our service center as well as the timeframes involved in completing the necessary work.”

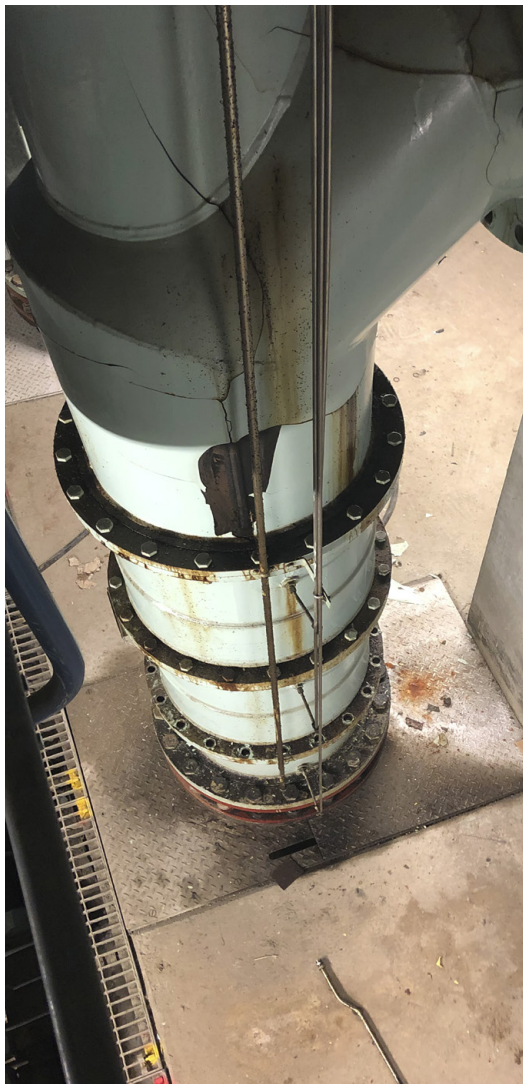
The project involved the complete overhaul of the pump and motor assemblies, all of which could be completed at the same location.

The project involved the complete overhaul of the pump and motor assemblies, all of which could be completed at the same location. As a turnkey solution, Sulzer provided field service engineers to arrange the lift and removal of the pump as well as the reinstallation of the full unit including motor, after the refurbishment had been completed.

Once the pump had been disassembled, all the components were inspected and identified for replacement or re-engineering. A considerable amount of corrosion was found on the impeller and the suction sleeves. Sulzer applied a specialist coating on all parts that required additional protection against corrosion to extend the operating life of these components.
