Rapid boiler feed pump repair and root cause analysis ensure power generation reliability

At a time when national electrical grids are under extreme pressure, unexpected outages can prove to be a considerable challenge. When a power plant in Germany experienced the sudden failure of a boiler feed pump, output dropped by more than 40%, which affected both the local grid and company profits. Needing to resolve this situation urgently, Sulzer was called in to repair the asset and conduct an investigation to secure the reliability of the power station

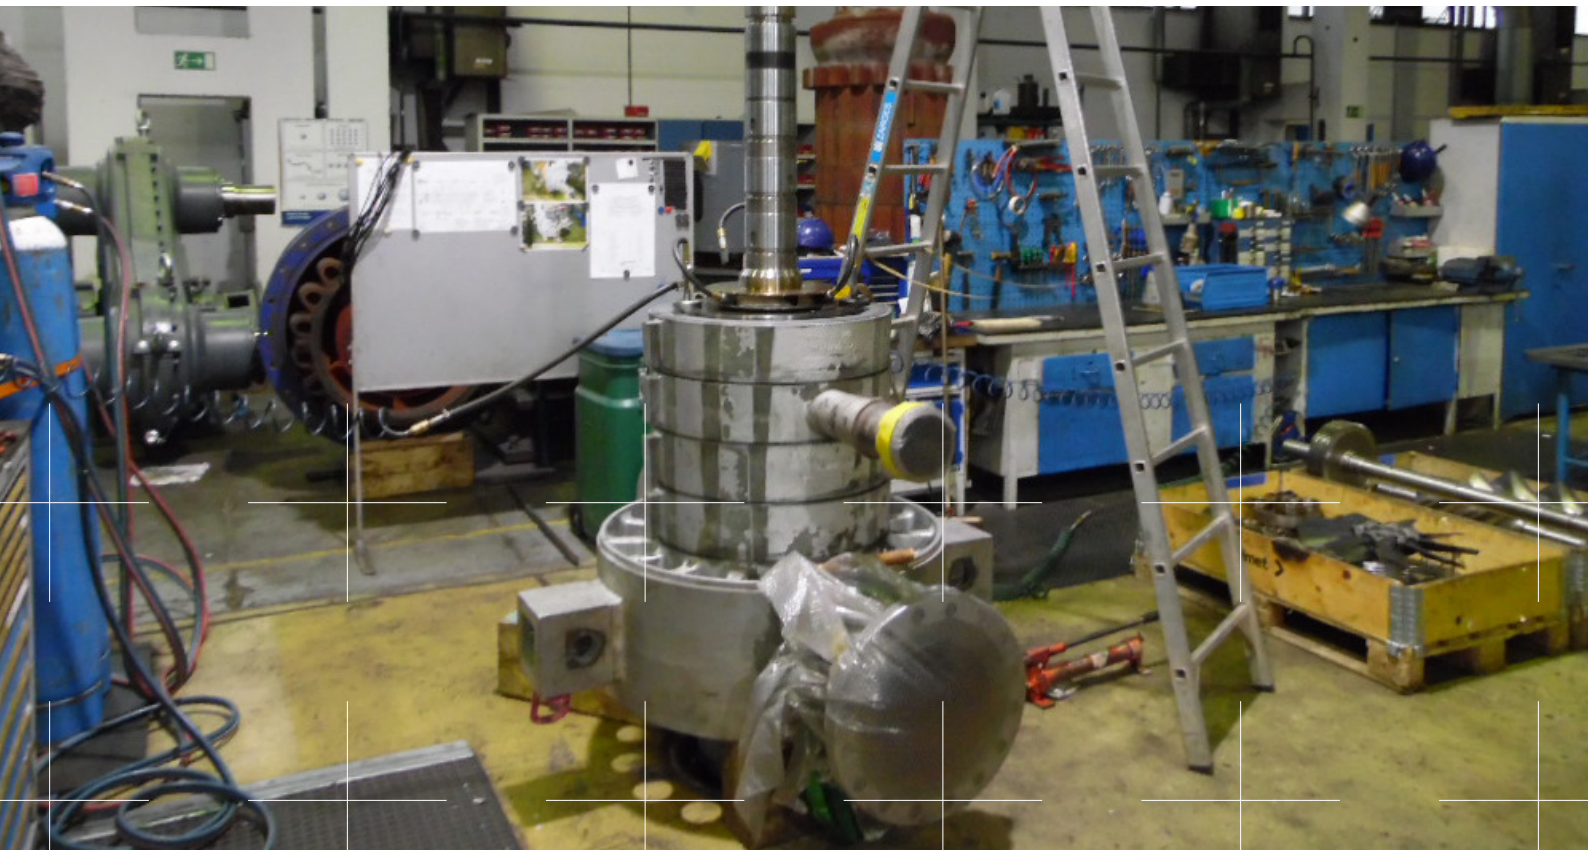
The power plant in question has two boiler feed pumps that have been in service for approximately 10 years without any issue. However, recently, the operator noticed a problem with the mechanical seals and called in Sulzer. The company responded immediately with specialist field service personnel on site the next day. Further investigation revealed that the pump was seized as a result of not following the correct start-up and maintenance procedures.

The initial investigation found that the balance piston and sleeve were welded together and this would require the shaft to be cut off and drilled out to separate the parts. The piston was replaced while a boring machine was used to bore out the sleeve to its original dimensions and complete the repair.

With the power plant running two of these pumps, the operator was very keen to identify the root cause of the initial problem to enable any additional preventative measures to be taken. During the inspection, there was evidence that a steam bubble was present in the area around the balance piston, indicating a lack of cooling and lubrication, which led to a massive rise in temperature. Some information that was missing during the initial investigation was that the plant suffered an unexpected shutdown two or three days before the pump failure took place. Once the reason for the shut-down was resolved, the pump was restarted, however, during this process a procedural issue was determined as the root cause of the subsequent pump failure, confirming the operational reliability of the pump.

The repaired balance piston was then fitted together with the spare rotor, which had passed its inspection. All the additional spare parts required for the repair were also on-hand having been ordered for urgent delivery.
