## Custom modified part reduces downtime costs for SAG mill operations

Gold miner

Sumatra, Indonesia

Motor services

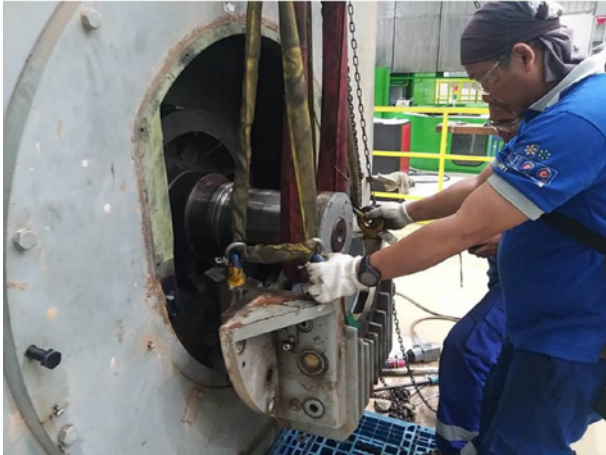
- Engineers at a gold mine in Sumatra noticed that the maintenance intervals for their 6.5 MW 3-phase slip ring SAG mill induction motors were becoming shorter
- A spare motor was activated to cover for the faulty unit while the operator needed expert support to quickly diagnose and determine the root-cause for the problem
- OEM support was not forthcoming.
- The mine operator took reference from their Australian counterparts who faced a rather similar issue.
- They sought the support from Sulzer Indonesia

- Upon detailed investigation, our engineers discovered carbon deposits had contaminated the windings.
- The carbon build-up could potentially cause a ground fault, that would damage the motor, necessitating a full rewind.

- The root-cause was that the motor OEM had omitted a slip ring chamber seal in its design.
- This allowed particles to enter the stator and build-up on the windings.

- We designed and supplied a custom modified slip ring chamber seal, preventing carbon dust entering the stator and contaminating the windings.
- A complete overhaul of the motor was delivered to ensure long term reliability.
