Machinery diagnosis

- Troubleshoot vibration and mechanical issues
- A clear route to reliable equipment

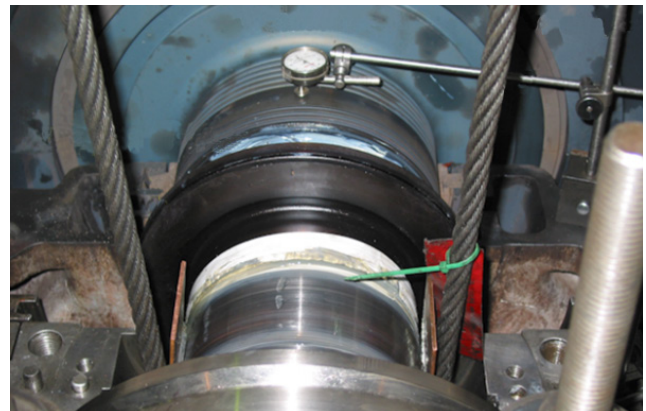
In close cooperation with the customer, Sulzer developed an extensive test plan for investigating the mechanism(s) responsible for the high vibration and associated power generation restrictions. During the outage of 2006-07 it was discovered that the bottom half of the #1 bearing was wiped and obviously overloaded. In order to verify bearing loads, a load reaction test was performed as shown in the adjacent photo. This test consisted of removing the bearing and measuring static load with a digital scale versus journal elevation with a dial indicator.

The results from this test are presented in the next graph. It is clear that elevation versus load was identical between the initial measurements from July of 2001 and October of 2006. Since the loading was identical, and the #1 bearing bottom half was wiped, it was necessary to reshoot the train optically. These vertical bearing position measurements revealed that the #1 bearing was sitting 30 mils higher than necessary, and the effective loading was substantially increased.

In the final evaluation, previous shaft vibration at 30 megawatts was 4.9 Mils,pp in March of 2006. Removing 30 mils of shims from the front standard allowed the train to run at desired output rate of 44 megawatts with only 1.5 Mils,pp of shaft vibration at the #1 bearing.
